Elm Creek Stream Restoration Site: A Demonstration in Channel Stabilization

Britta J. Suppes

University of Minnesota- TC
Graduate Assistant
supp0014@umn.edu

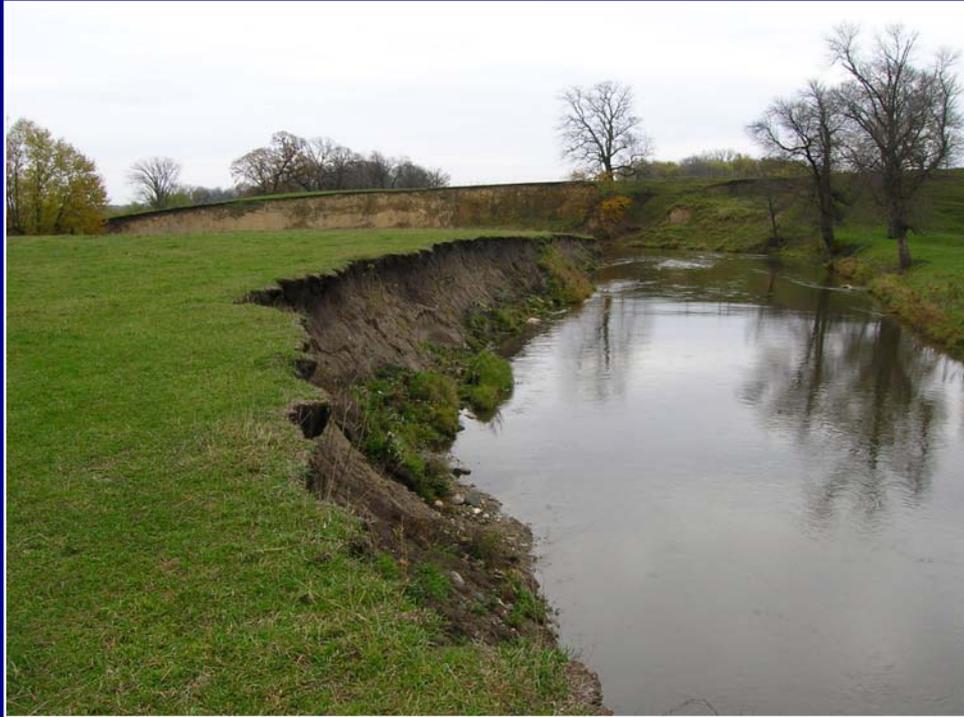
Elm Creek Basin: PRESENT

- Severe channel erosion in Elm Creek and other streams in the Blue Earth River Basin
 - Increased peak flows
- Mass wasting
 - Slumping
 - Causing property damage and loss

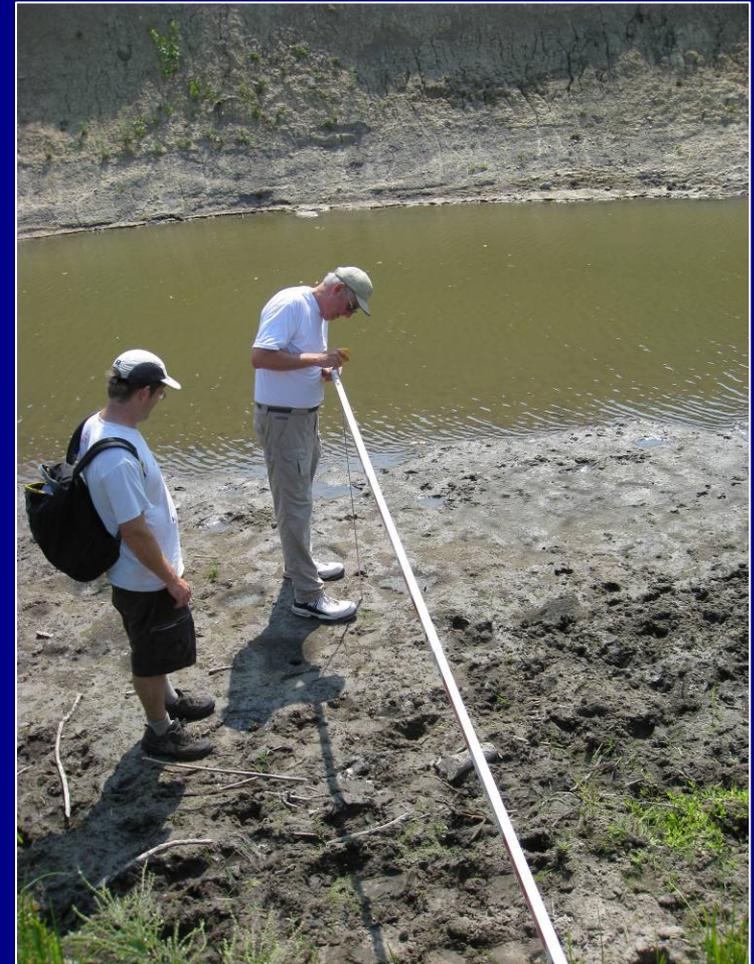
LASER
LEVEL

- Measurements Taken:
 - Channel width
 - Channel depth
 - Channel slope
 - Channel material
 - YSI Measurements
 - Water Quality sampling
- Calculations for design:
 - Width/Depth ratio
 - Entrenchment ratio
 - Bankfull level
- Rosgen Method
- Pfankuch Stability Assessment

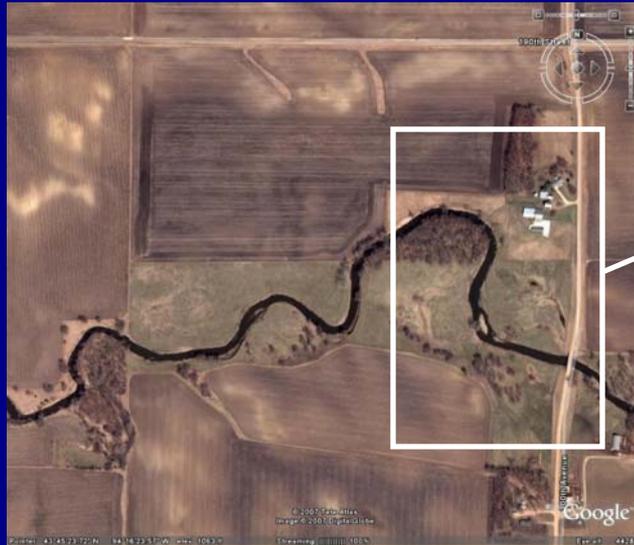
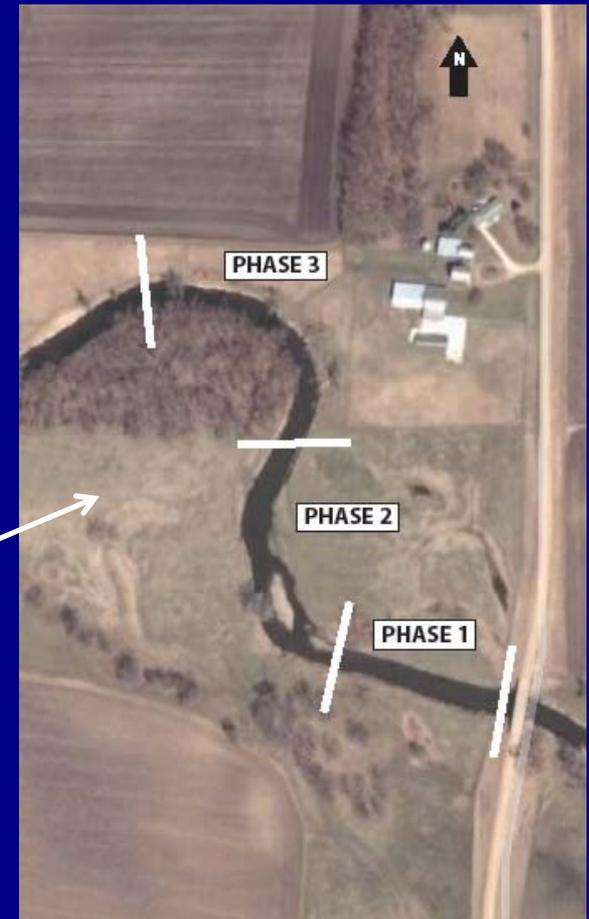
Phases 1-3: Guide

- The demonstration site was divided up into 3 phases
- Restoration designs were made for each phase (1-3)

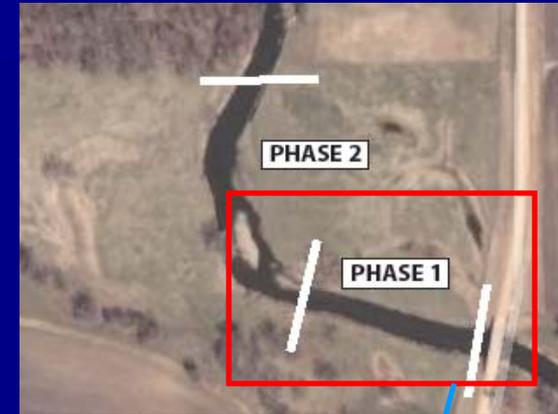
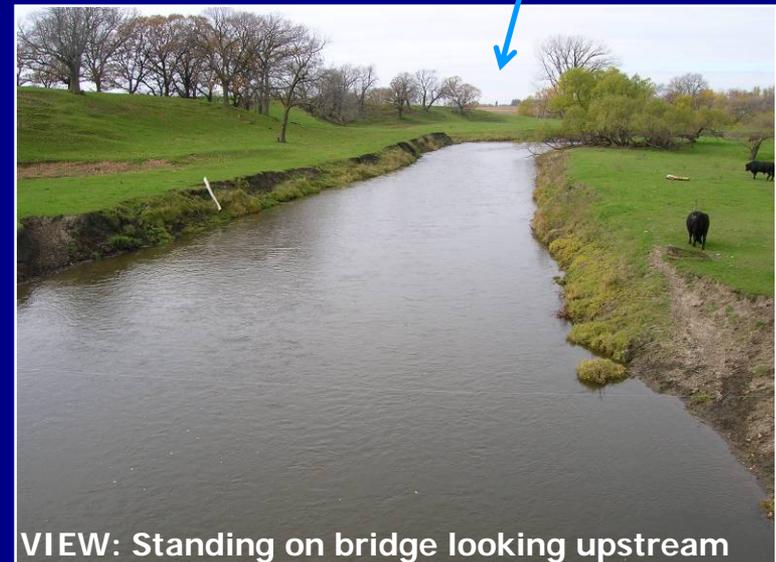
- Heavy cattle grazing
 - No riparian buffer
 - Minimal vegetation besides turf grass
 - Soil compaction=surface runoff
 - Highly impacted and eroded cattle crossings
- Channel Straightened
 - Channel was straightened for bridge crossing
 - Oxbow cut off unnaturally
- Stream entrenchment
 - Elm Creek is entrenched at Phase 1
 - Stream cannot access flood plain during peak flows

VIEW: Standing on bridge looking upstream

1. Revegetate left bank with perennial vegetation
2. Reshape bank
 - Recreate bankfull levels and floodplain
 - Stabilize with erosion control fabric and veg
3. Stabilize cattle crossing

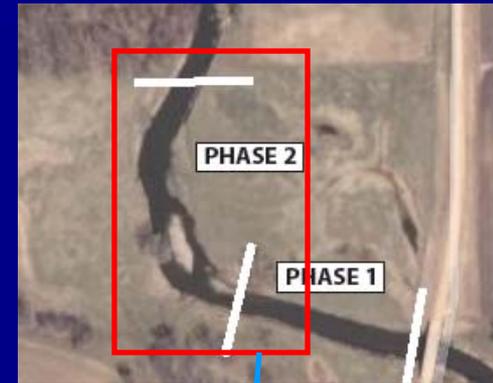
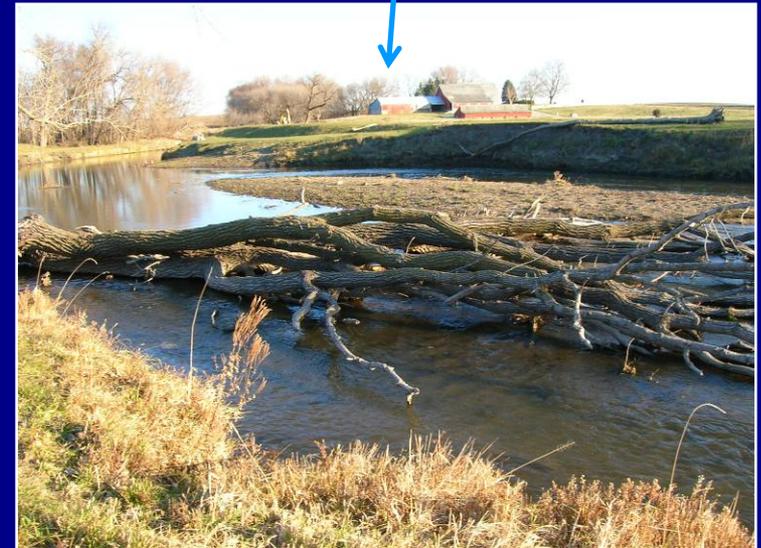
- Cattle crossing caused the stream to widen
- Sediment deposition in center of channel
 - Created two channels
- No riparian buffer vegetation

- Elm Creek is entrenched at Phase 2
- Stream cannot access flood plain during peak flows

View: Standing on RB looking north, upstream

1. Reconnect oxbow to active channel
 - To reduce energy of flow during high water
 - Construct cross vane to redirect flow in channel during high water
 - Construct step ladder at oxbow exit
2. Reshape bank
 - Recreate bankfull levels and floodplain
 - Stabilize with erosion control fabric and veg
3. Revegetate left bank with perennial vegetation
4. Stabilize cattle crossing
5. Remove aggraded sand bar to create a single channel

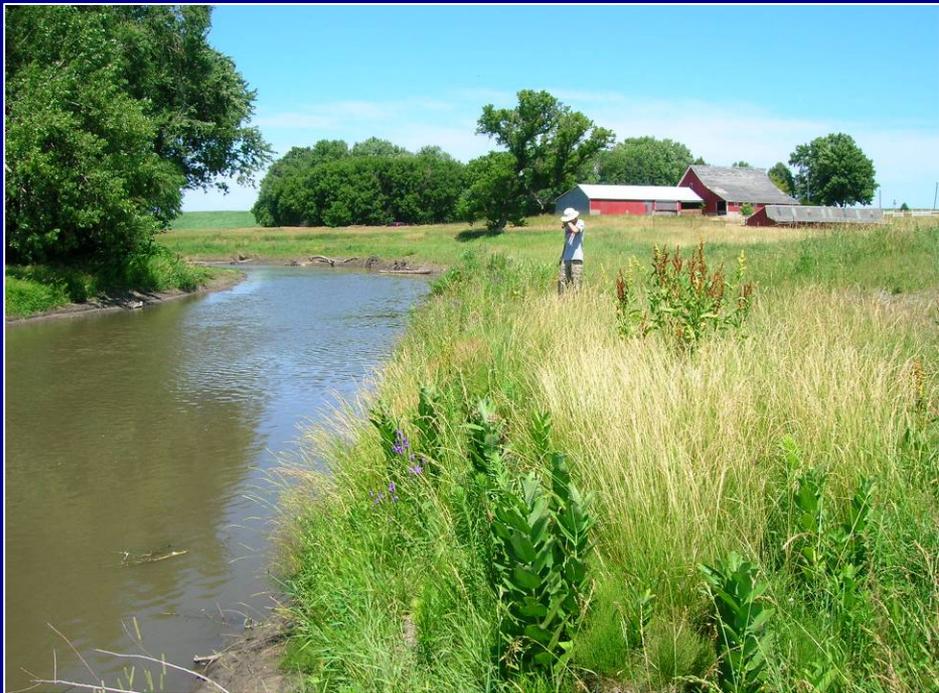
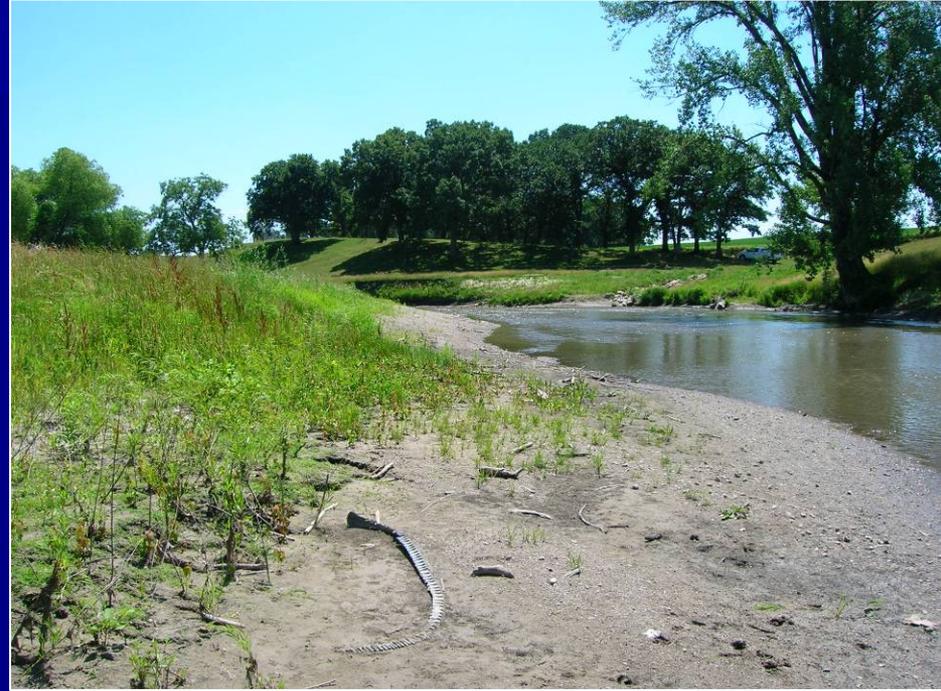
Phase 2: Photos

7/17/08

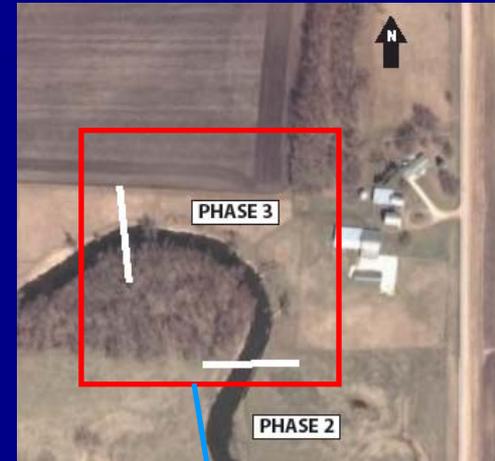
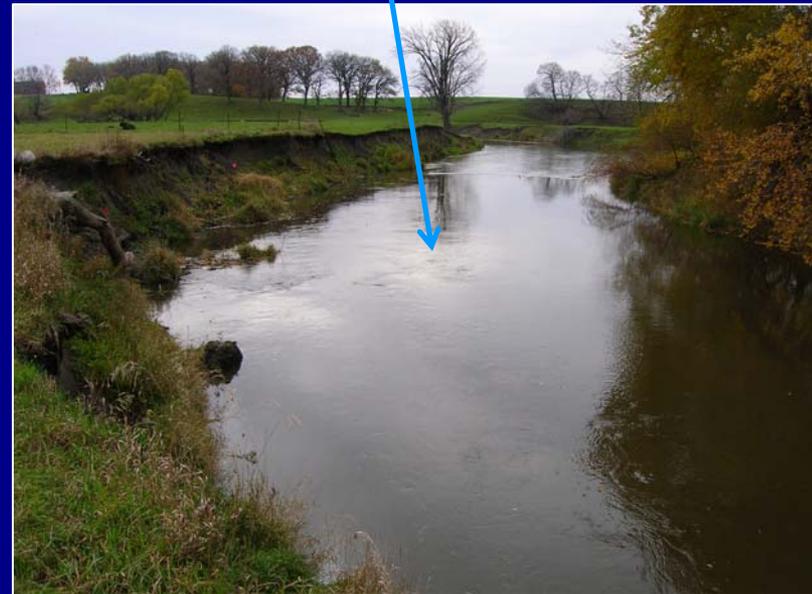
- Cutbank is eroding at an estimated rate of ~5 ft/yr
 - Quickly eroding into Stensland property
- Stream entrenchment
 - Elm Creek is entrenched at Phase 3
 - Stream cannot access flood plain during peak flows

1. Emplace 6 tree vanes
 - Deflect flow away from cutbank
2. Reshape bank
 - Recreate bankfull levels and floodplain
 - Stabilize with erosion control fabric and veg
3. Revegetate left bank with perennial vegetation
4. Emplace root wads

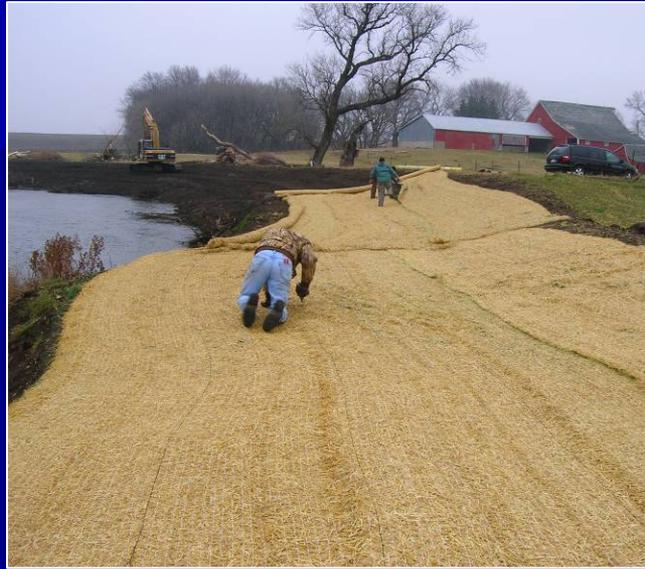
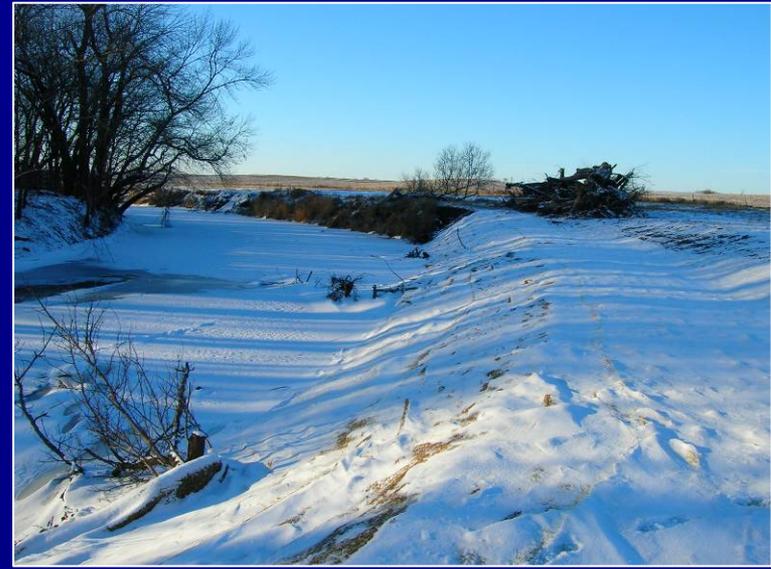
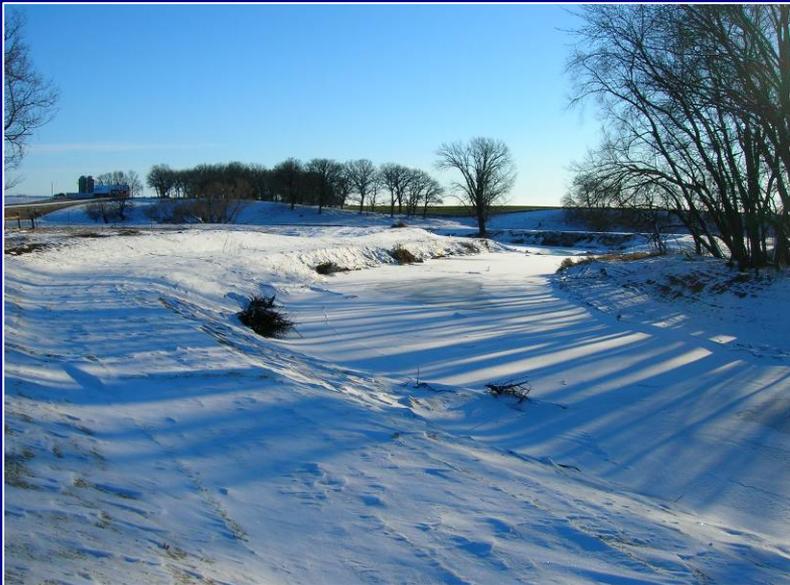
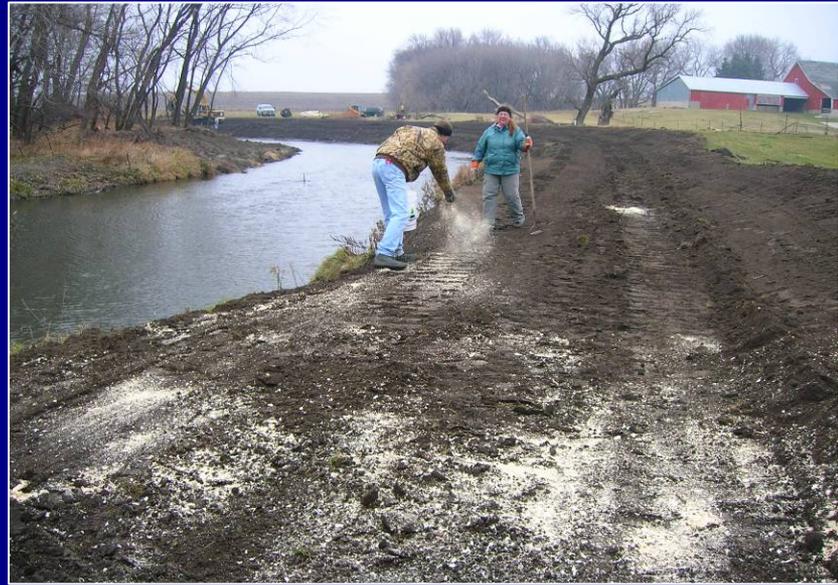
AFTER:
Nov. 2007

- Contractor finished work on 11/26/07
- Weather forced us to cease work
 - Ground frozen by 11/28/2007
- Restoration work continued Spring 2008

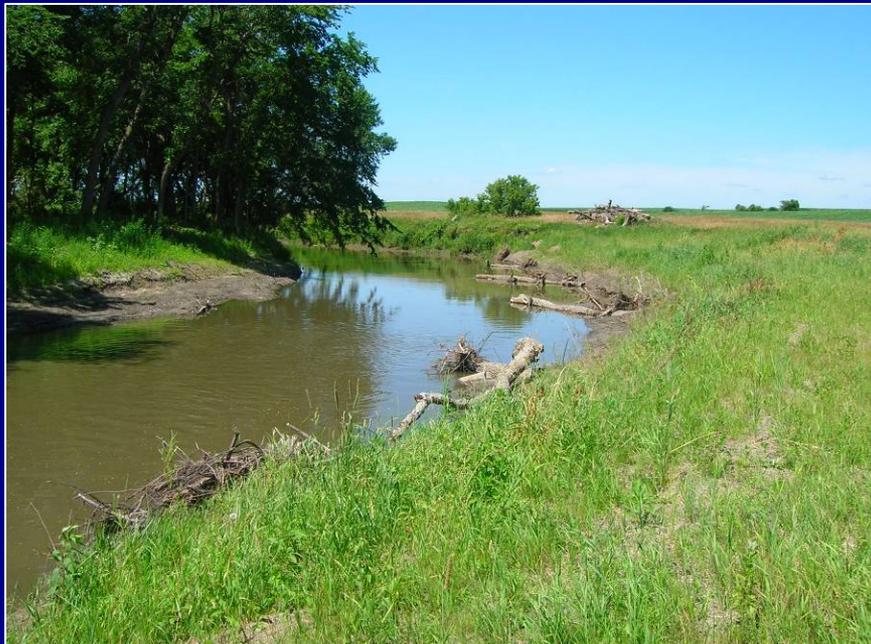
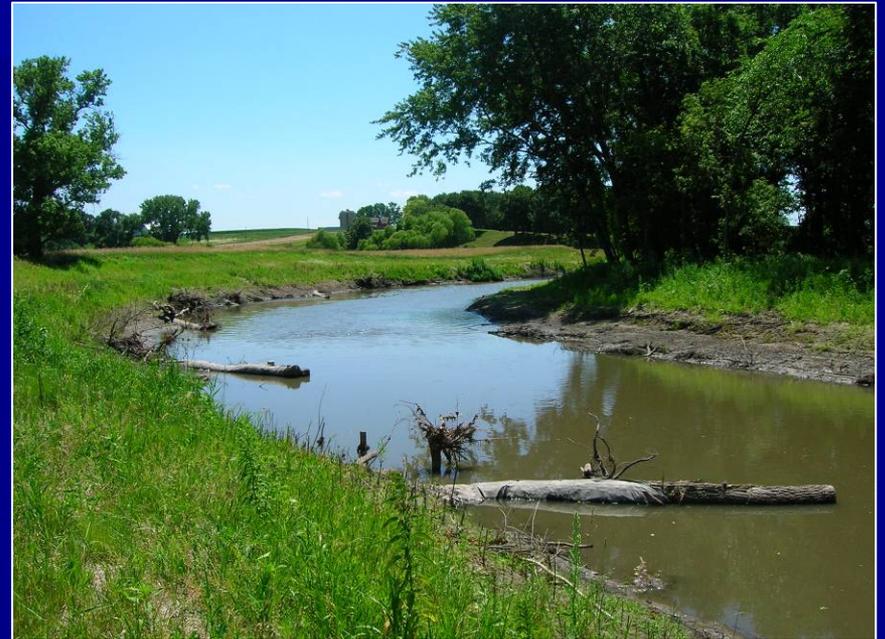
Phase 3: Photos

AFTER:
7/17/08

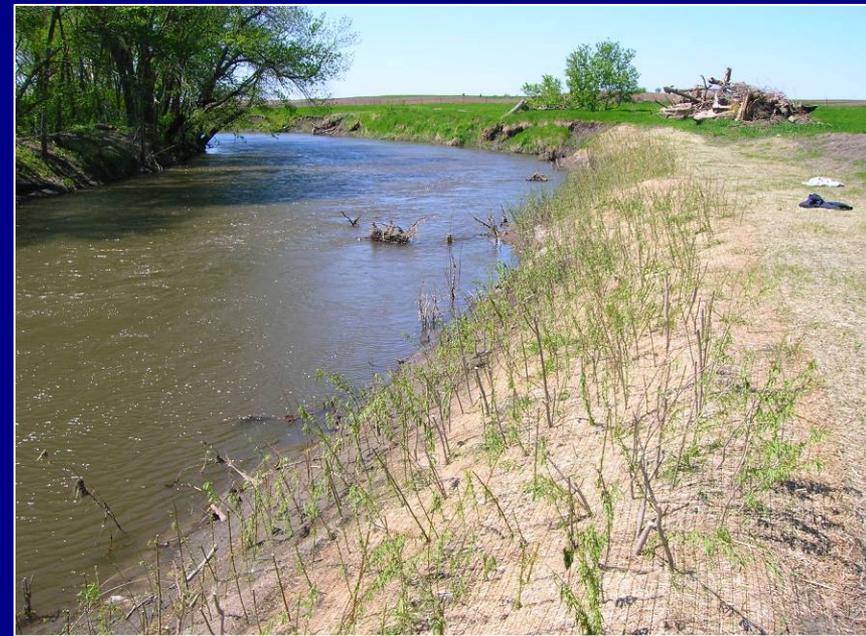
- Planted prairie grasses on exposed, raw stream banks
- Stapled erosion control fabric on raw banks
- Planted willow stakes in riparian areas
- Developed a long term perennial vegetation plan
 - Used landowner input to select ideal vegetation
 - Agroforestry opportunities

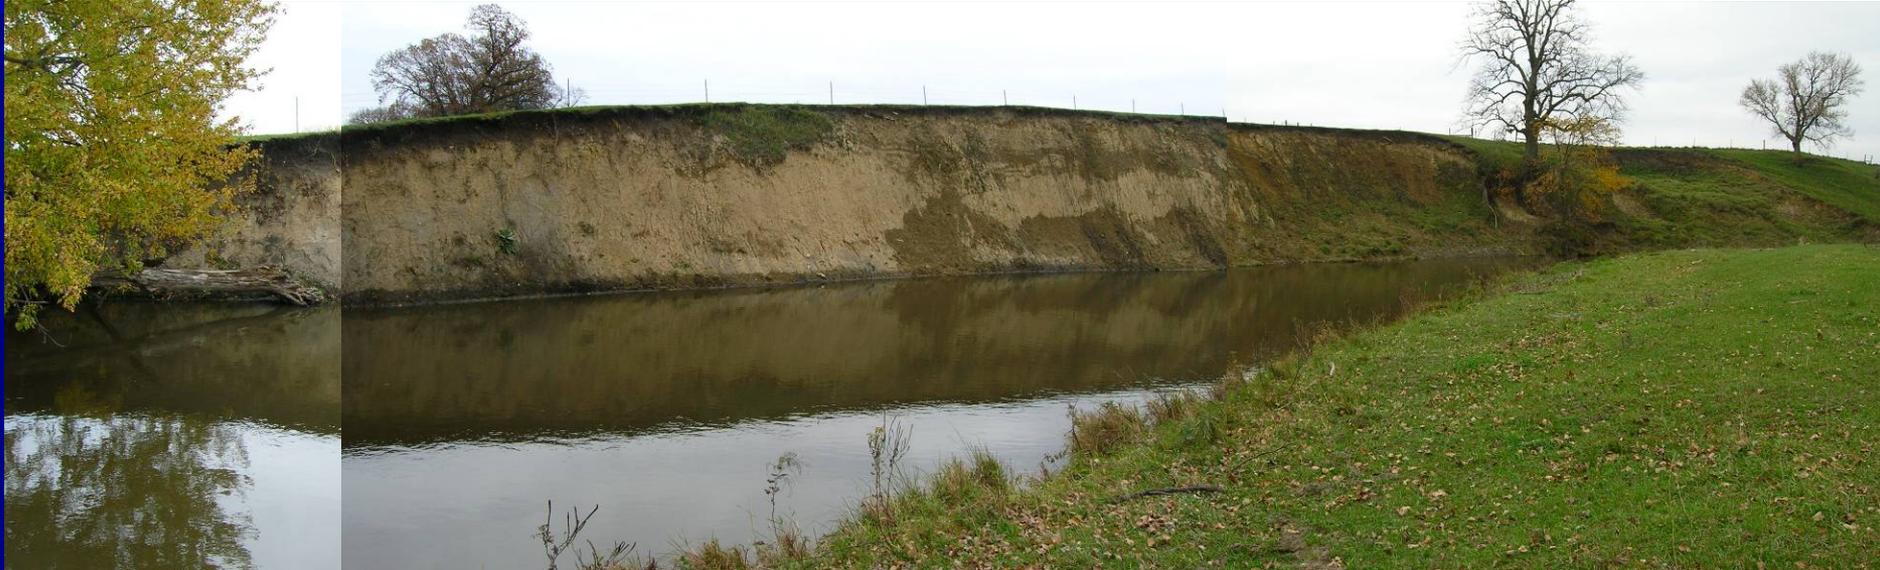
Phase 4– Pre-Restoration (Before)

- Channel erosion
- Mass wasting (slumping)
- Channel widening
- Grazing degradation
- Limited riparian vegetation
- Shallow rooting depths of grasses

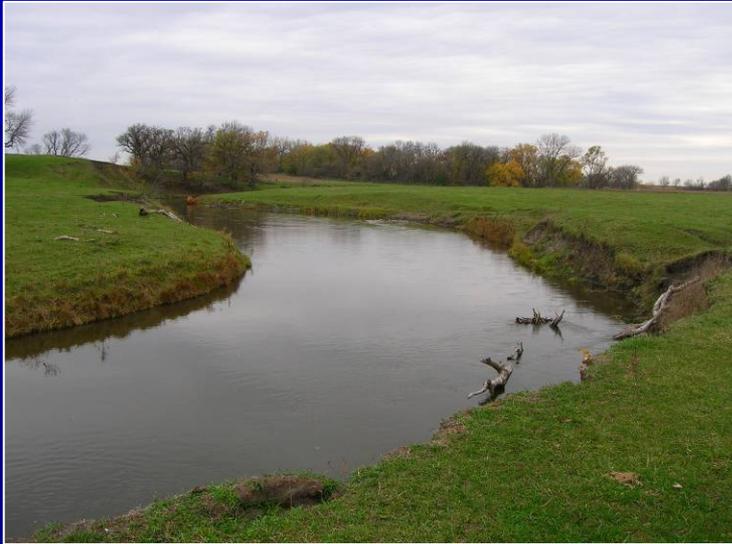
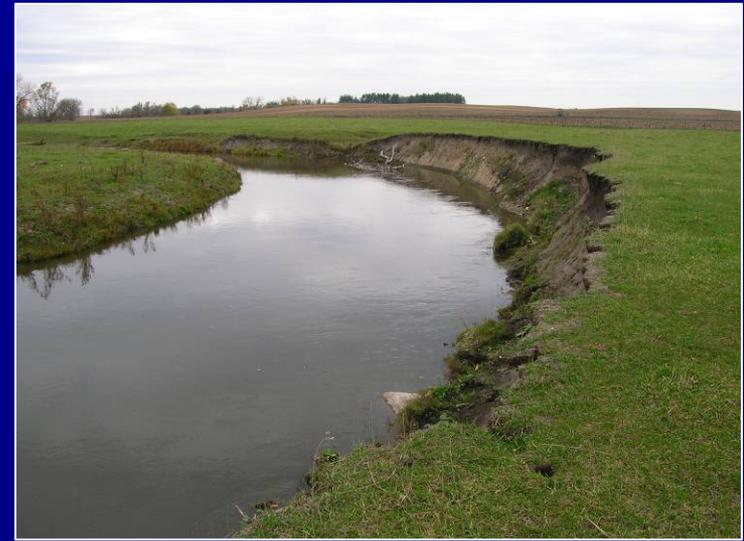
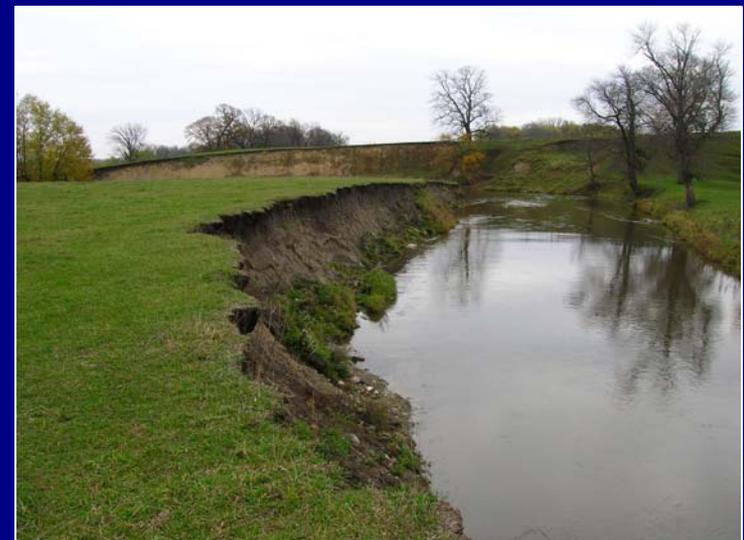
Phase 5– Pre-Restoration (Before)

- Channel erosion
- Mass wasting (slumping)
- Channel widening
- Grazing degradation
- Limited riparian vegetation
- Large cattle crossing in channel

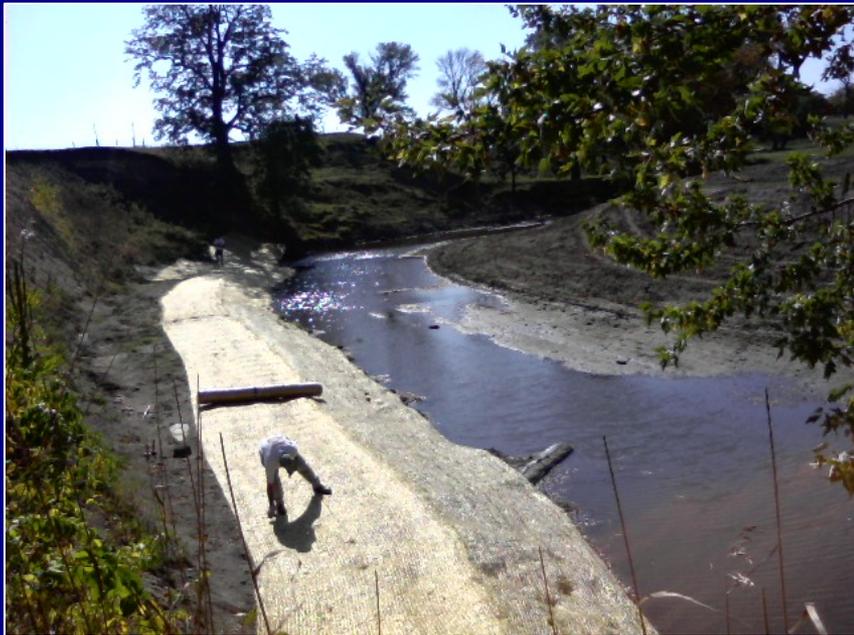
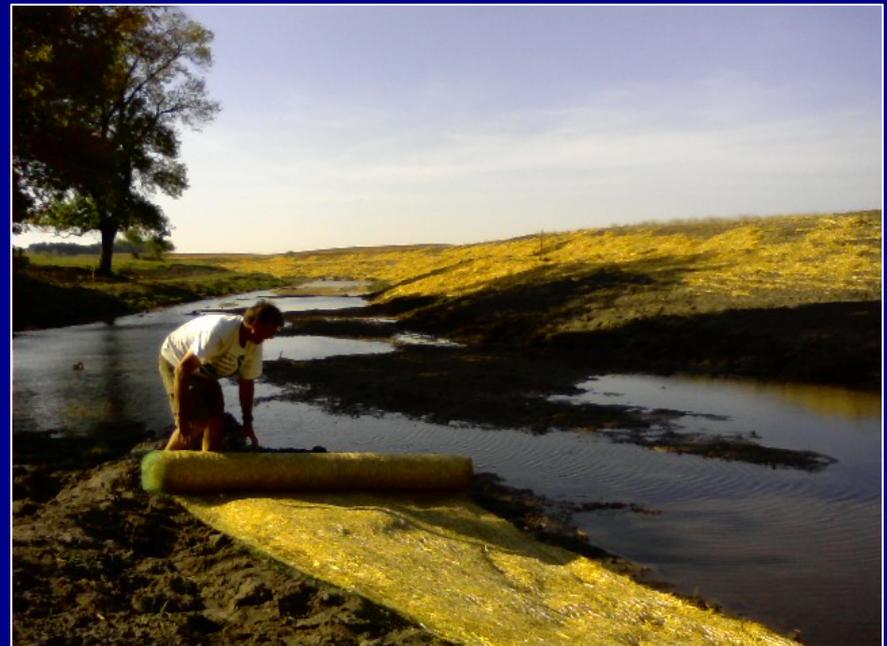
AFTER Construction: Phases 4 & 5

- Construction completed Sept. 2008
- Perennial grasses and willows planted Oct. 2008
- Erosion control fabric stapled onto bare soil
